ILC-NML Cryo September Test run results:

The south refrigerator was commissioned and performance tested along with the north compressor. The commissioning and tests were done without shift work or evening hours. In summary the refrigerator ran well with a refrigeration load but fell short with a liquefaction load.

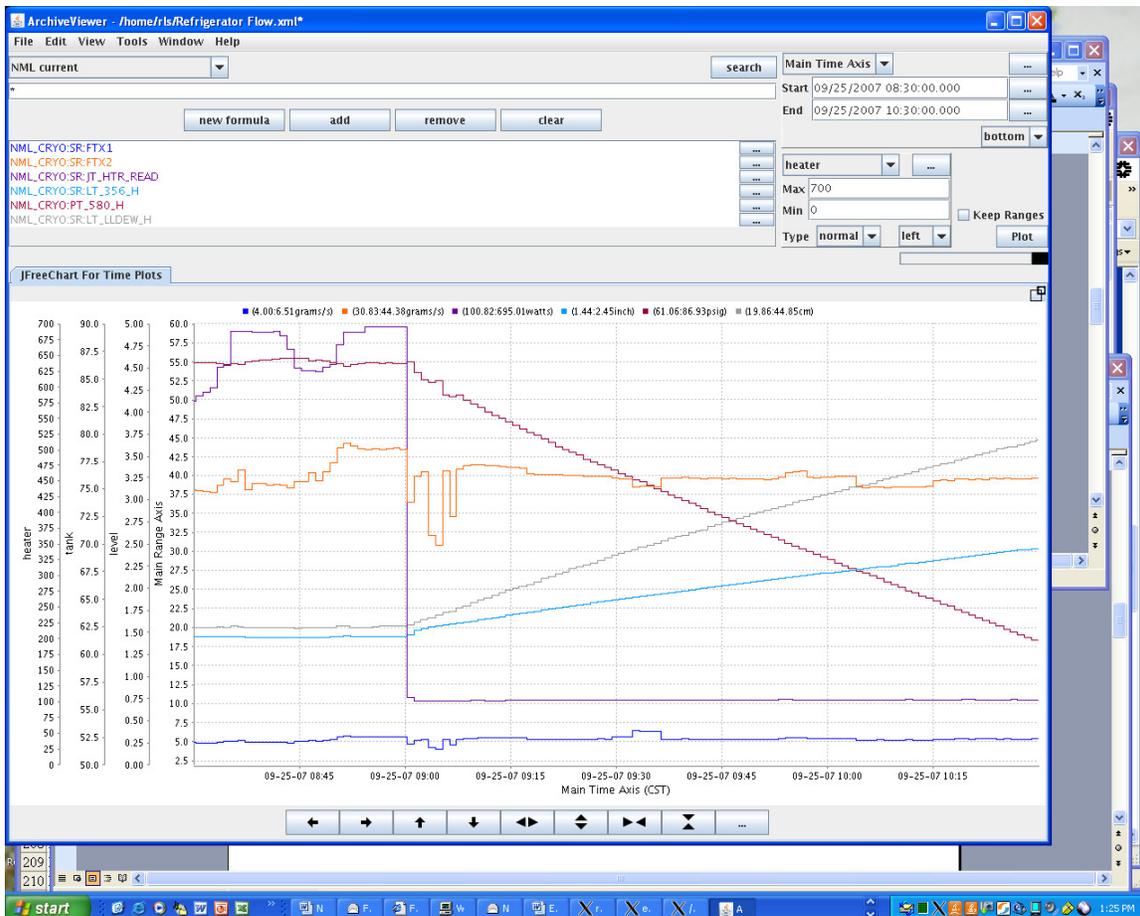
- The flow was too imbalanced during the liquefaction test, both engines and TVX1 all ran warmer than they should. Total flow was 45 g/s and it should have been 60 g/s. Three problem areas are identified:
 - PVXBY is too small. While it did affect the wet engine inlet temperature, when fully open it could not pull the temperature below 8.2K.
 - PVX2 was stuck open during part of the test and the trim was too big. At the end of the test it was repaired and a smaller trim installed. The control loop for this valve needs adjustment. During the testing TVX1 was about 118K.
 - The dry engine temperatures are suspicious. Indication of a dry inlet of 44K and 79% efficiency don't fit with the inability to pull down the temperature.
- Performance testing data, heat load on left, liquefaction on the right.
